**Flood Control Project Maintenance
Levee Inspections**

Fall 2011 Levee Maintenance Deficiency Summary Report

Sacramento River Basin

Marysville Levee Commission

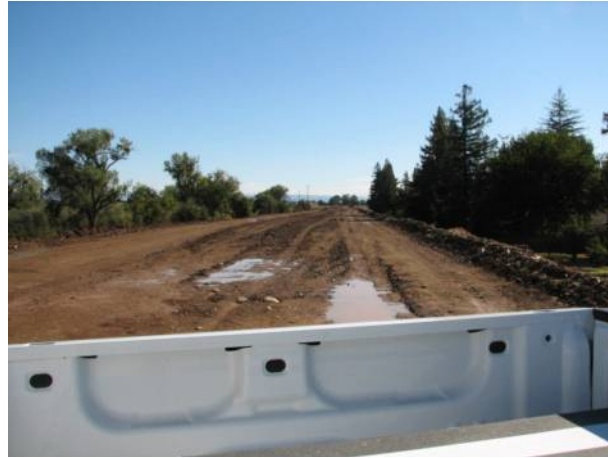
Levee Mile Report Line	3
Start Levee Mile	2.55
End Levee Mile	2.55
Location	Crown
Category	Earthen Levee
Item	Crown Surface / Depressions / Rutting

This photo was taken near levee mile 2.55, looking downstream.

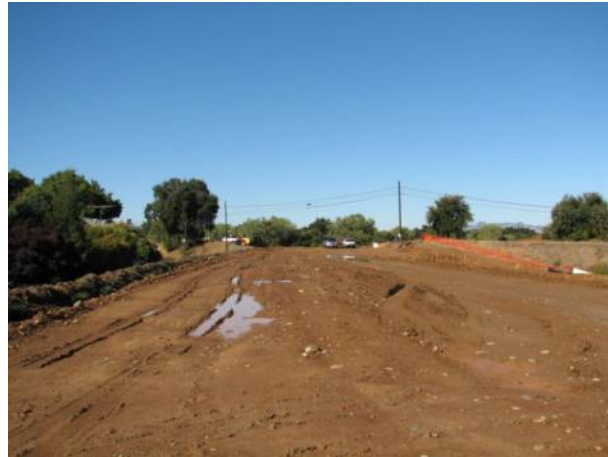
Levee Mile Report Line	3
Start Levee Mile	2.55
End Levee Mile	2.55
Location	Crown
Category	Earthen Levee
Item	Crown Surface / Depressions / Rutting

This photo was taken near levee mile 2.55, looking upstream.

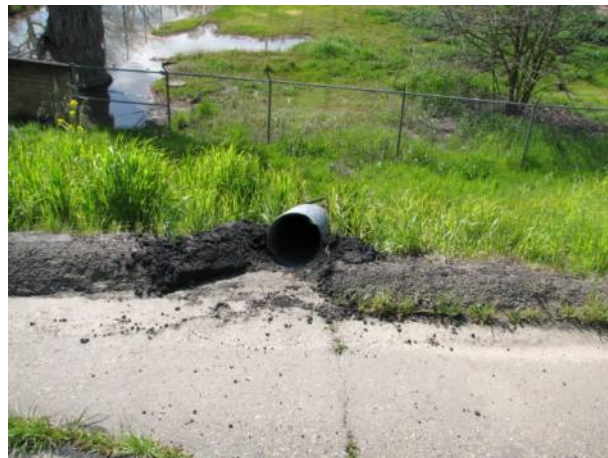
Levee Mile Report Line	4
Start Levee Mile	3.21
End Levee Mile	3.21
Location	Land Side
Category	Earthen Levee
Item	Slope Stability

This site is on the Corps PI.

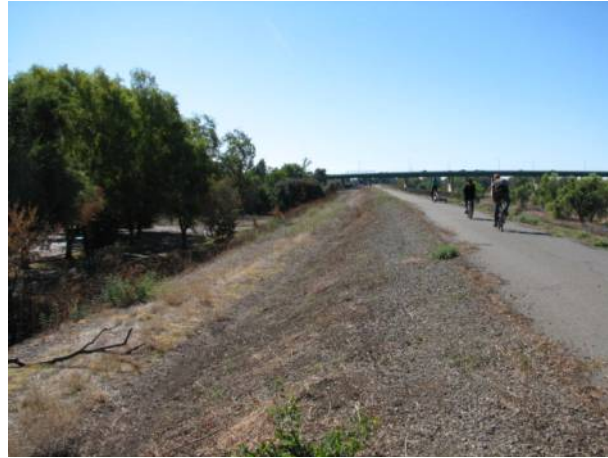
Levee Mile Report Line	1
Start Levee Mile	0.02
End Levee Mile	1.25
Location	Land Side
Category	Earthen Levee
Item	Vegetation

This photo shows the landside vegetation at levee mile 0.08.

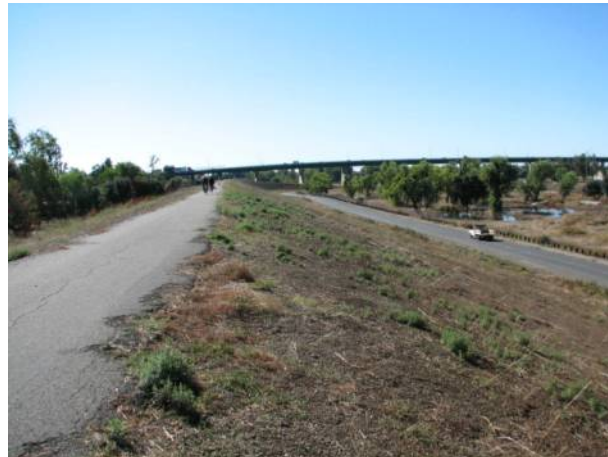
Levee Mile Report Line	2
Start Levee Mile	0.02
End Levee Mile	1.24
Location	Water Side
Category	Earthen Levee
Item	Vegetation

This photo shows the waterside vegetation at levee mile 0.08.

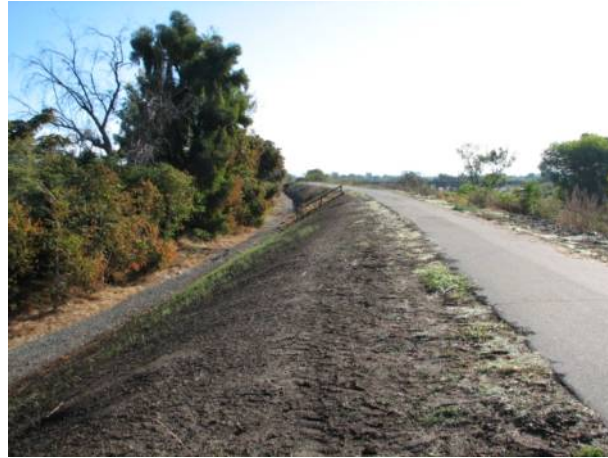
Levee Mile Report Line	1
Start Levee Mile	0.00
End Levee Mile	4.88
Location	Land Side
Category	Earthen Levee
Item	Vegetation

This photo shows the landside vegetation looking upstream from levee mile 0.27.

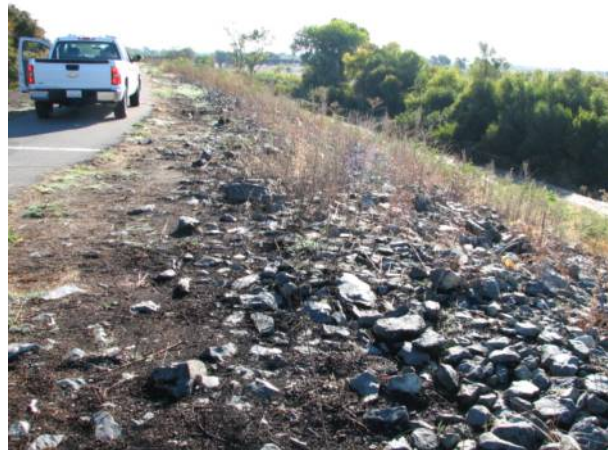
Levee Mile Report Line	2
Start Levee Mile	0.00
End Levee Mile	4.88
Location	Water Side
Category	Earthen Levee
Item	Vegetation

This photo shows the waterside vegetation looking upstream from levee mile 0.27.

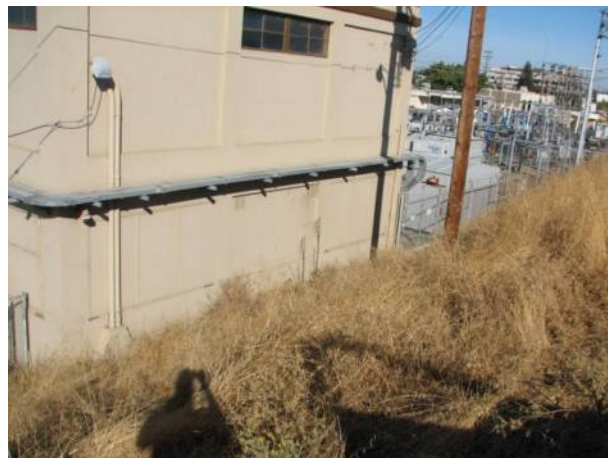
Levee Mile Report Line	4
Start Levee Mile	0.86
End Levee Mile	0.86
Location	Land Side
Category	Earthen Levee
Item	Encroachments

Building encroaching at land side levee toe.

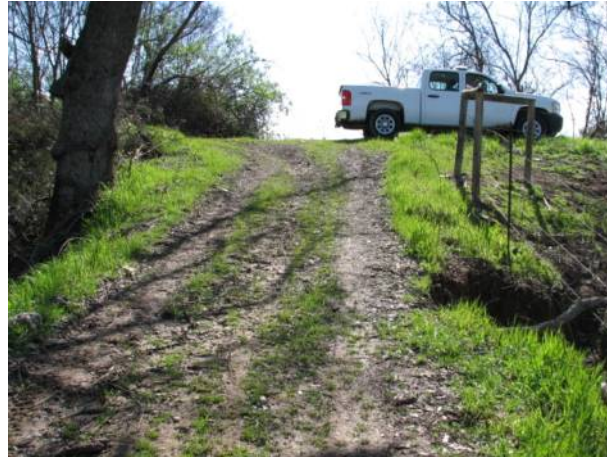
Levee Mile Report Line	11
Start Levee Mile	5.54
End Levee Mile	5.54
Location	Crown
Category	Earthen Levee
Item	Encroachments

11	5.54	5.54	Earthen Levee	Encroachments	CR	PO	Ramp Inspector Comments: This is on the patrol road.	39.190993 ° -121.530650 °	39.190993 ° -121.530650 °	10 Y

This ramp is on the patrol road, no known permit.
